**CLEAN WATER ACT  
COMPLIANCE INSPECTION**

Facility Name

Moorefield, WV 26836

On-Site Inspection – May 22, 2012

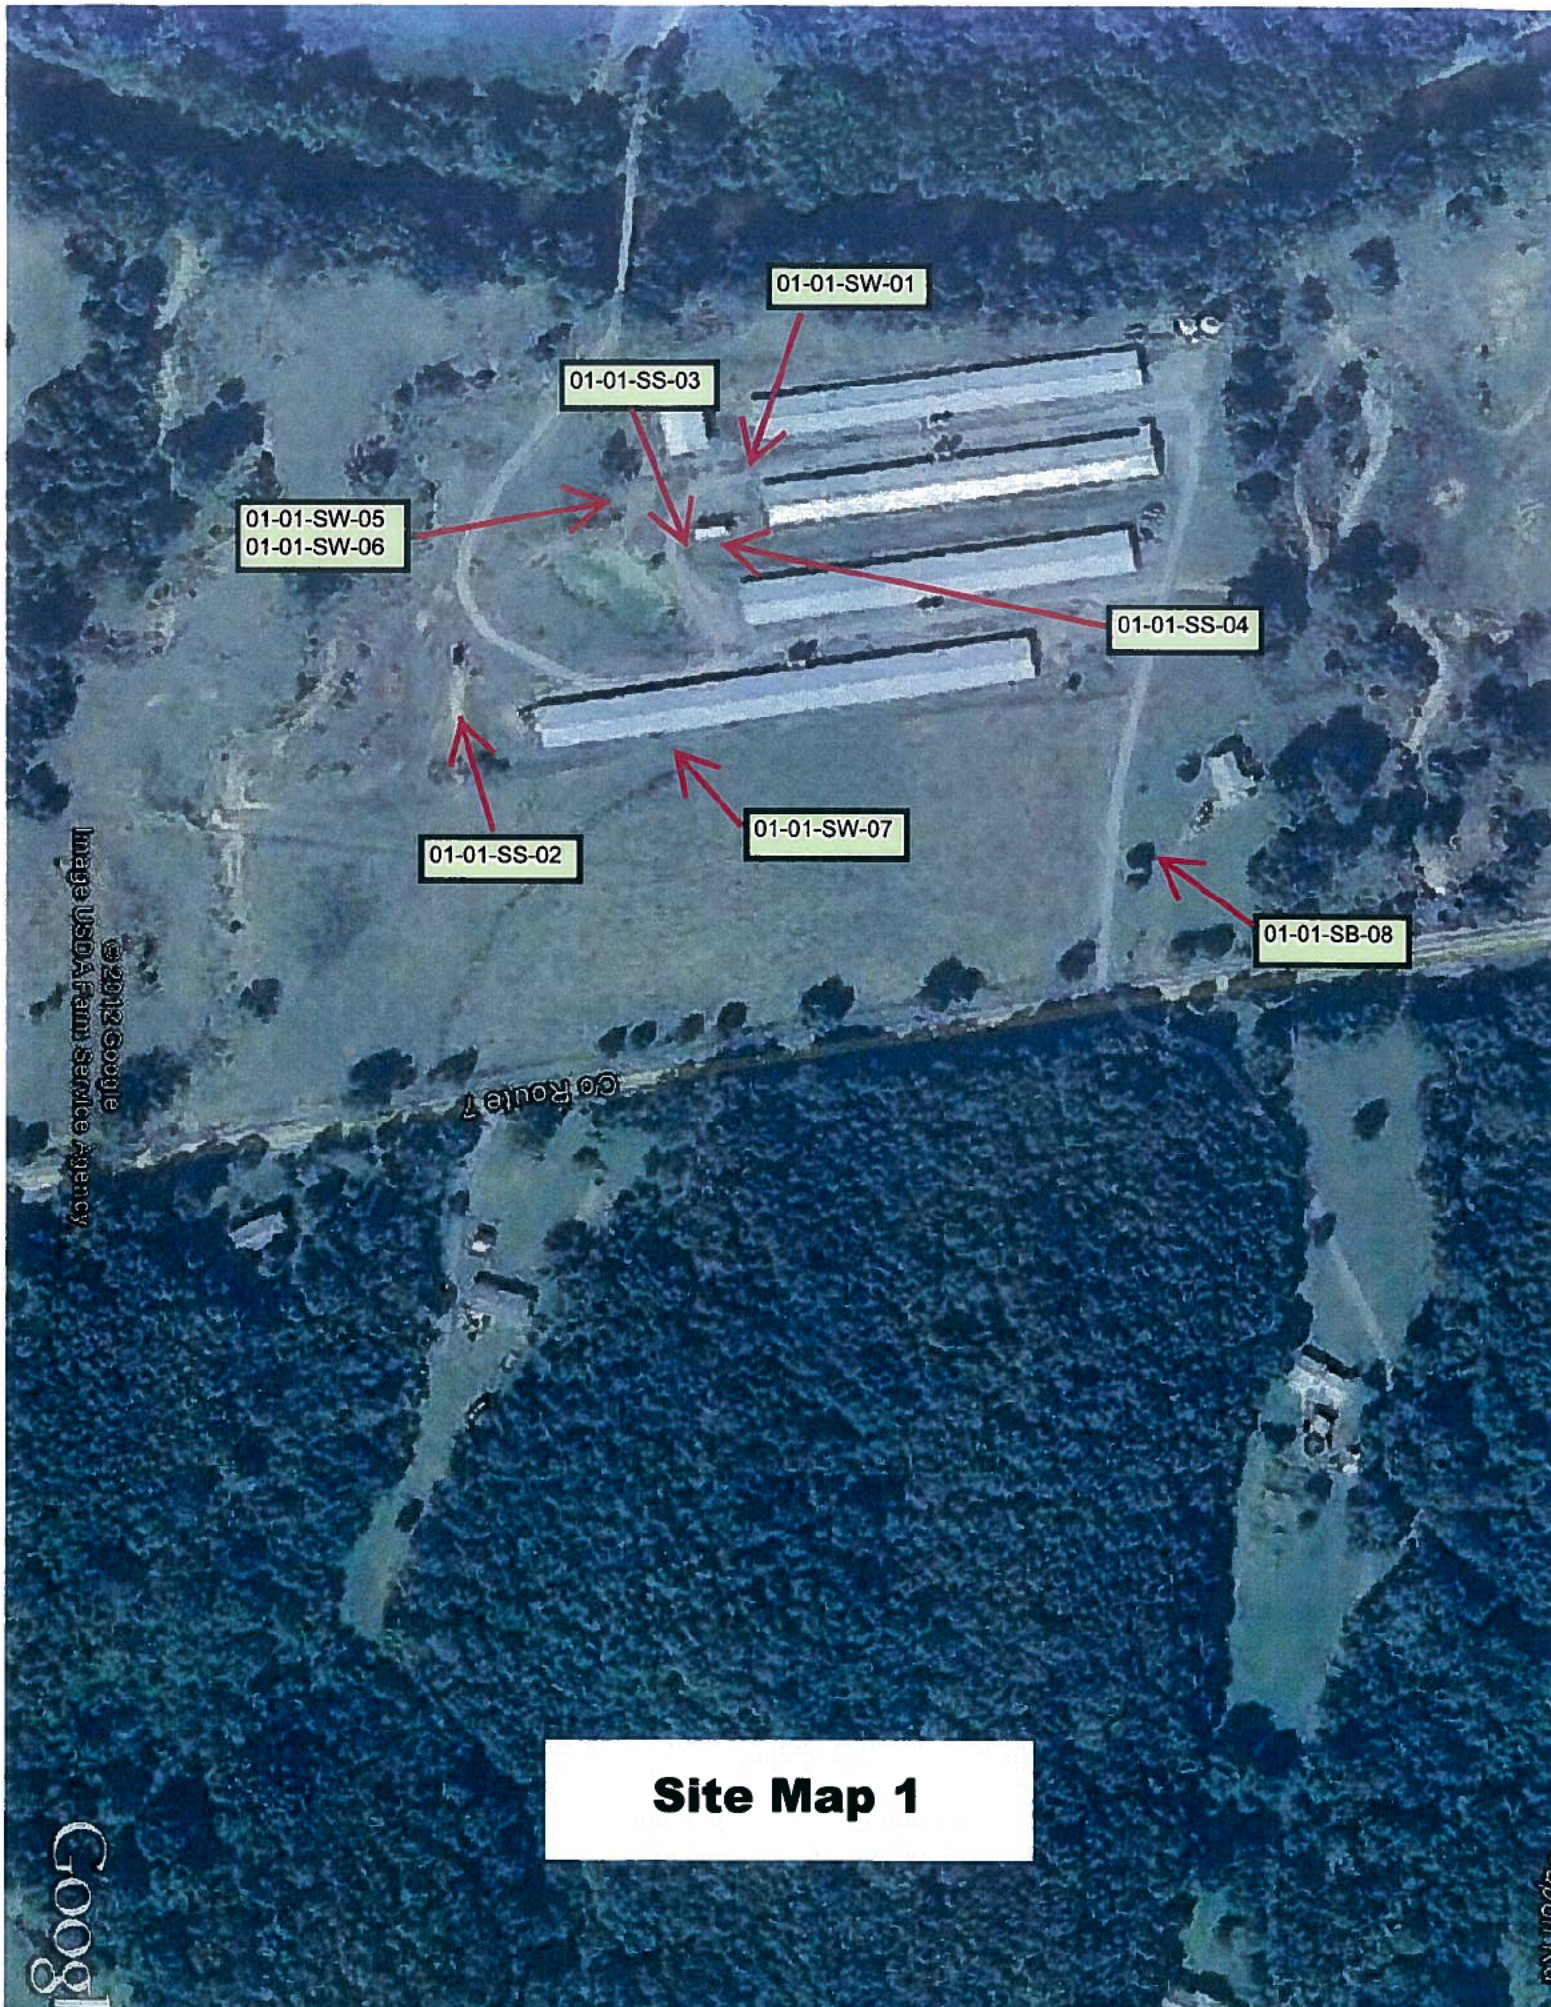
**Site Map 1**

SAIC collected eight (8) samples and prepared one (1) field blank. Details about each sample are listed in Table 1. The on-site sampling locations are shown on Site Map 1. Photographs of the sampling locations include, but are not limited to, Photos 8, 43, and 44. A summary of the sample results are provided in Tables 2-4 with the corresponding analysis report for each sample provided in Appendix D. All samples were taken the day of the inspection.

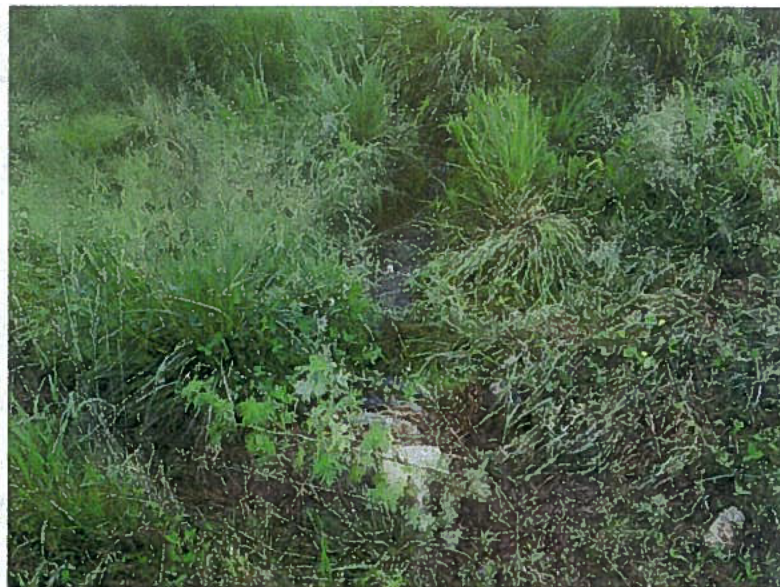
Photo 8

There is a ditch along the east and south sides of House 4 (see Photos 7 and 9). The end pad at the south end of House 4 (see Photo 6) is approximately 30 feet from this ditch (see Photo 10). [REDACTED] stated that he has seen water flow from this ditch through a culvert under an access lane (see Photo 11) into the Farm Pond. One stream enters the Facility from the east (see Photo 8) and is conveyed through a culvert under House 4 to the Farm Pond (see Photo 13).

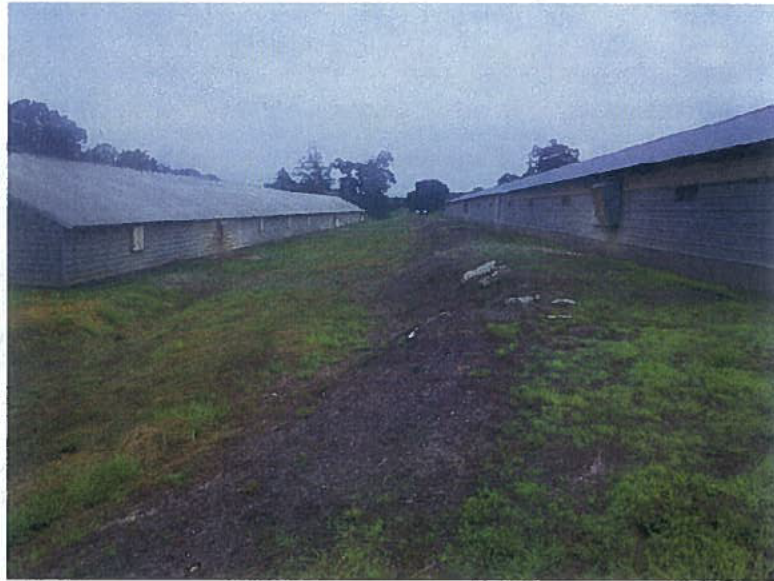
Photo 11	2012-05-22--10.49.49 [REDACTED]	Culvert to farm pond from ditch along east and south sides of House 4
Photo 12	2012-05-22--10.52.58 [REDACTED]	Access lane between Houses 3 and 4 with standing water in depressions; Farm Pond on the left
Photo 13	2012-05-22--10.54.32 [REDACTED]	Farm Pond
Photo 14	2012-05-22--10.54.49 [REDACTED]	Drainage path from access road area on the west side of House 4
Photo 15	2012-05-22--10.55.17 [REDACTED]	South end of House 3
Photo 16	2012-05-22--10.55.43 [REDACTED]	Area with ditch between Houses 2 and 3
Photo 17	2012-05-22--10.55.43-1 [REDACTED]	Area with ditch between Houses 2 and 3

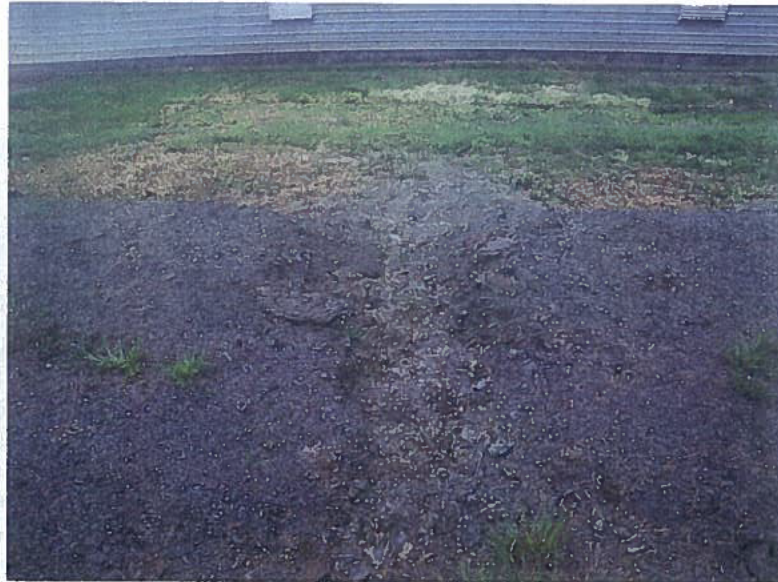
Photo 18	2012-05-22--10.56.17 [REDACTED]	Ground below ventilation fan on the west side of House 3 with dust and feathers
Photo 19	2012-05-22--10.58.13 [REDACTED]	Drainage ditch from elevated area next to House 3 toward ditch between Houses 2 and 3
Photo 20	2012-05-22--10.58.57 [REDACTED]	Dust and feathers below other ventilation fans on House 3 in relation to drainage ditches
Photo 21	2012-05-22--10.59.52 [REDACTED]	North end of House 3
Photo 22	2012-05-22--11.00.04 [REDACTED]	Drainage path from north end of House 3 down access lane on the north side of the Facility
Photo 23	2012-05-22--11.00.31 [REDACTED]	North end of House 2
Photo 24	2012-05-22--11.00.41 [REDACTED]	Looking south from the north end of House 2 at ditch between House 2 and 3
Photo 25	2012-05-22--11.01.01 [REDACTED]	Dust and feathers below ventilation fan on House 2 in ditch between House 2 and 3
Photo 26	2012-05-22--11.01.55 [REDACTED]	Area below ventilation fan adjacent to saturated area in ditch between House 2 and 3

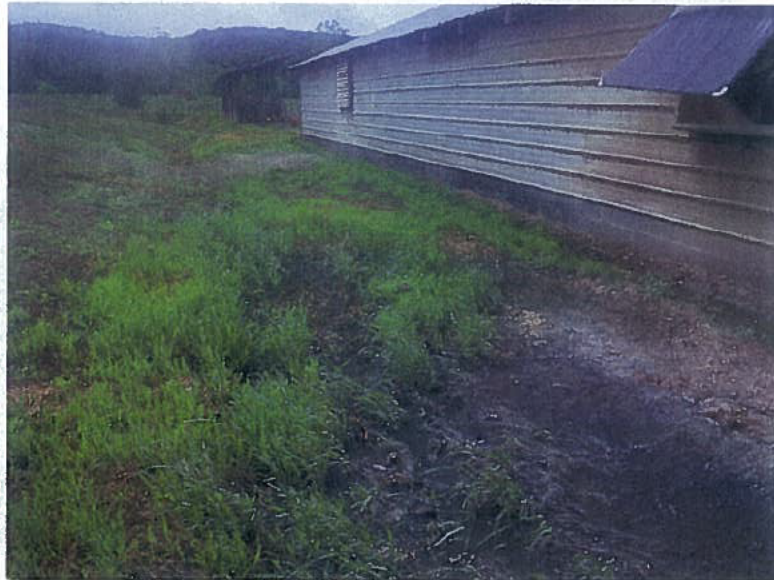
Photo 27	2012-05-22--11.02.58 [REDACTED]	Standing water in ditch between House 2 and 3
Photo 28	2012-05-22--11.03.04 [REDACTED]	Ventilation fan on House 2 in relation to standing water in ditch between House 2 and 3
Photo 29	2012-05-22--11.04.00 [REDACTED]	Area below another ventilation fan on House 2 adjacent to ditch between House 2 and 3
Photo 30	2012-05-22--11.04.45 [REDACTED]	Ditch between Houses 2 and 3 near culvert to Farm Pond
Photo 31	2012-05-22--11.04.58 [REDACTED]	Culvert from ditch to Farm Pond
Photo 32	2012-05-22--11.05.46 [REDACTED]	Culvert outlet to Farm Pond
Photo 33	2012-05-22--11.06.09 [REDACTED]	Mortality compost shed to the south of House 2 and west of ditch between Houses 2 and 3
Photo 34	2012-05-22--11.06.21 [REDACTED]	Manure shed with farm equipment
Photo 35	2012-05-22--11.06.54 [REDACTED]	Area between House 2 and manure shed
Photo 36	2012-05-22--11.07.07 [REDACTED]	Area in front of manure shed

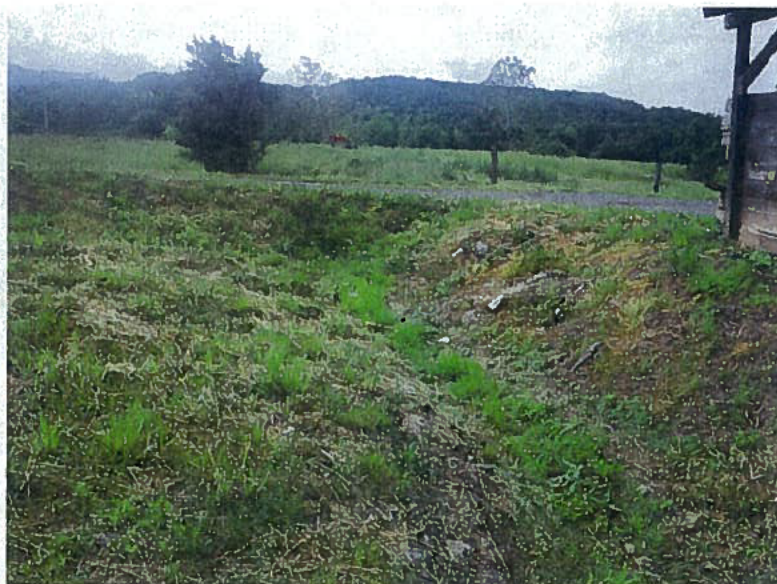
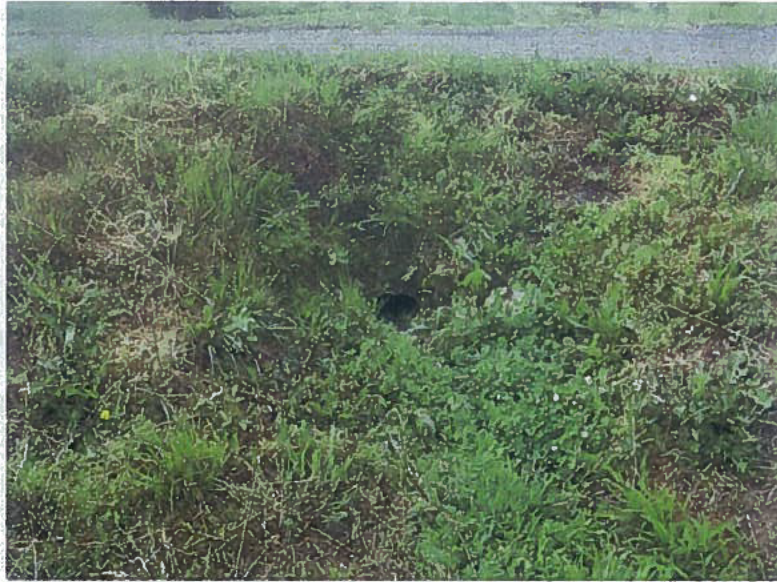
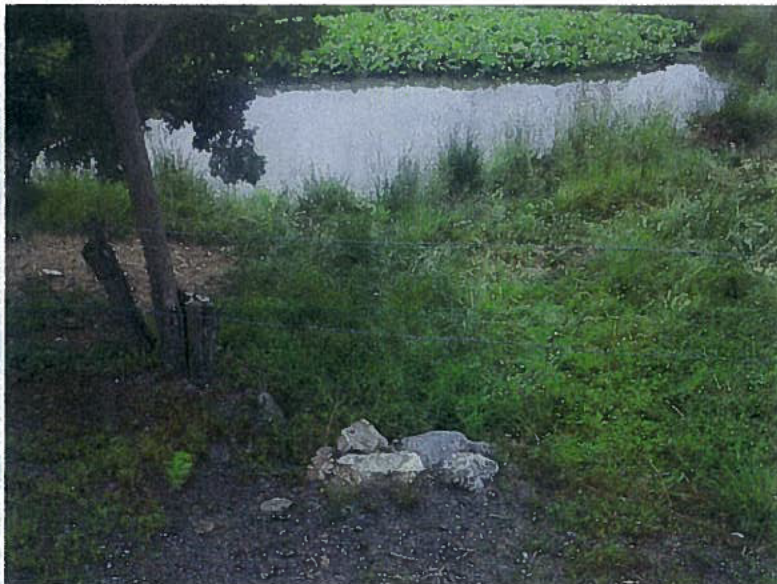
There are other ditches and drainage pathways that flow to the Farm Pond. I observed a drainage path from the access road area on the west side of House 4 (see Photo 14). There is a large ditch between Houses 2 and 3 (see Photo 16). This ditch flows through a culvert into the Farm Pond (see Photos 30-32). House 2 is at a lower elevation than House 3 (see Photos 17 and 24). I observed dust and feathers on the ground below the ventilations fans on Houses 2 and 3 next to the large ditch (see Photos 18, 25, 26, and 29). I observed drainage paths from the area adjacent to the ventilation fans on House 3 down toward the ditch (see Photo 19). There was standing water in the ditch between House 2 and 3 (see Photo 27). The water in the ditch was below a ventilation fan on House 2 (see Photo 28).

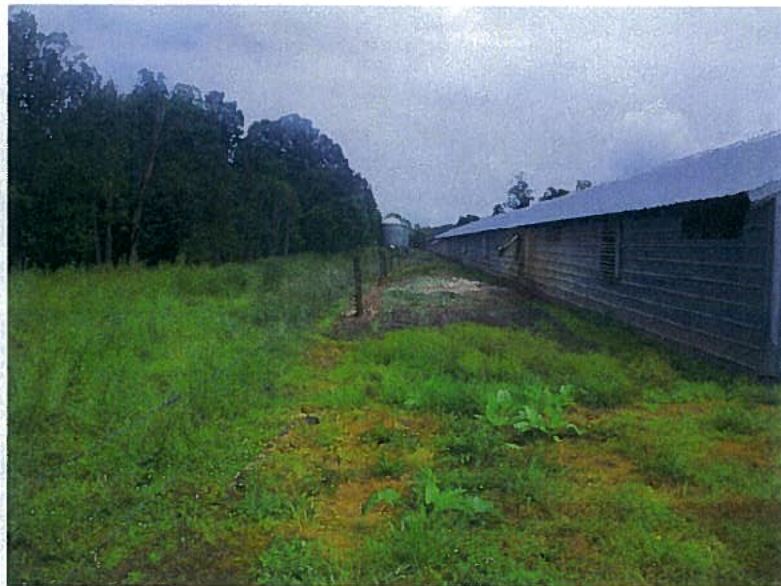
Photo 40	2012-05-22--11.12.35 [REDACTED]	Area to the west of House 1
Photo 41	2012-05-22--11.25.51 [REDACTED]	Area at the north end of House 4 with access lane between Houses 3 and 4
Photo 42	2012-05-22--11.33.08 [REDACTED]	Saturated area in ditch between Houses 1 and 2
Photo 43	2012-05-22--11.33.28 [REDACTED]	Stormwater in puddle from ditch between Houses 1 and 2; Sampling Location
Photo 44	2012-05-22--13.37.35 [REDACTED]	Outlet of Farm Pond; Sampling Location
Photo 45	2012-05-22--14.37.08 [REDACTED]	2012 EQIP Cost Estimate – List of Proposed BMPs
Photo 46	2012-05-22--15.07.42 [REDACTED]	GPS Unit - Used to sync with digital camera
